Evaluation for Corrosion Characteristic of Steel Girder Bridge

Structure LAB 065338B Naoto Maruyama

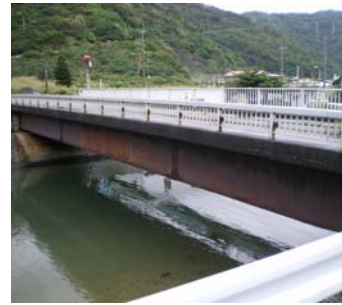
Corrosion environment for steel material in Okinawa is a severe accelerated corrosion environment because of high humidity with high temperature, and huge amount of the air-borne salt. A weathering steel bridge had been exposed for 28 years in Okinawa, Kunigami Village. The weathering steel bridge is located only 50m from the coast, and it existed in the environment to which a huge amount of air-borne salt adhered by the north strong wind. As a result, severe corrosion damages were happened the end of girders.

Photo.1 Corrosion Bridge

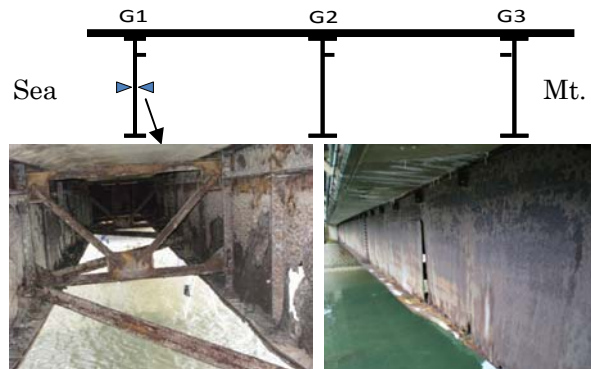
Fig.2 Corrosion Situation (inside and outside)

The difference in between a corrosion situation inside and outside in the main girders are shown in **Fig.2**. The supplemental rust controlling surface treatment remains, and the cleansing property by rain can be confirmed to two main girders (G1, G3). On the other hand, it was a situation in which nonadherent layered rust almost occurred on the entire surface in inside aspect. The difference of the corrosion of the center part and the end of the main girder is shown in **Fig.3**.

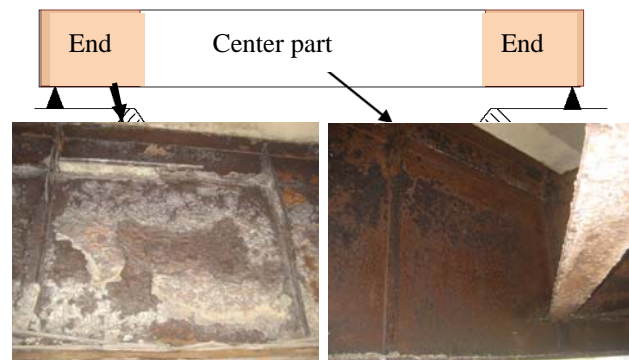
As a result of detailed investigation, the rust of the center part of the main girders becomes less than the rust of the end, and a decrease in web thickness in the center part is less than the web thickness at the end.

Fig.3 Corrosion of the center part and the end

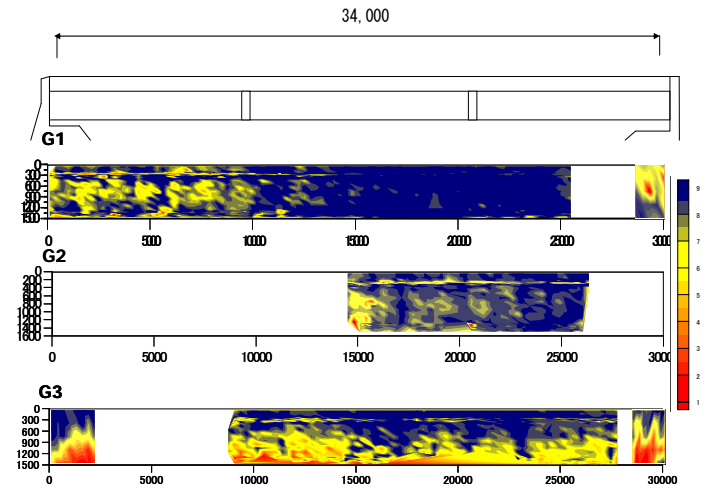
Fig.5 Web thickness distribution

The web thickness distribution from G1 to G3 is shown in Fig.5. The web divides by the web enclosed with a vertical stiffener. There are the web panels from P1 to P24. The obtained findings are listed as follows.

- (1) On G1 girder from P1 to P7 panels, the web thickness decreases of the center part. However, from P8 to P18 panels is about design thickness of 9 mm.
- (2) The web thickness of G3 becomes thin toward the lower flange from upper flange. Furthermore, intense corrosion produces the end of the main girder.
- (3) G2 corrodes from both sides and corrosion of G2 is not intenser than G3.

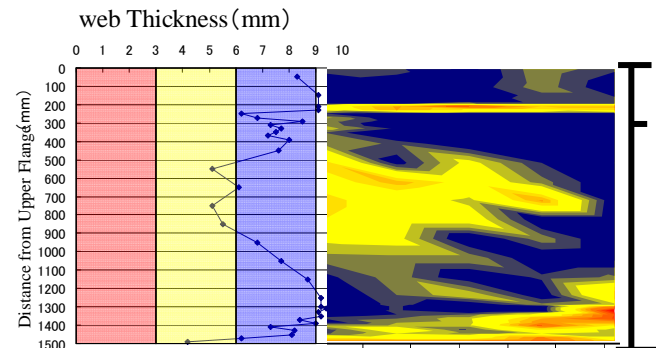
Fig.6 End of the main girder (G1-P4)

The web thickness characteristic and the amount of the web thickness in span central part and the end is shown in Fig.6 and Fig7. The obtained findings are listed as follows.

- (1) The corrosion characteristic of the end of G1. The thickness of center part of a web decreased.
- (2) The corrosion characteristic of the center part of G3. A decrease in board thickness under the web is intense.
