Evaluation for Corrosion Characteristic of Steel Girder Bridge

Structure LAB 065338B Naoto Maruyama

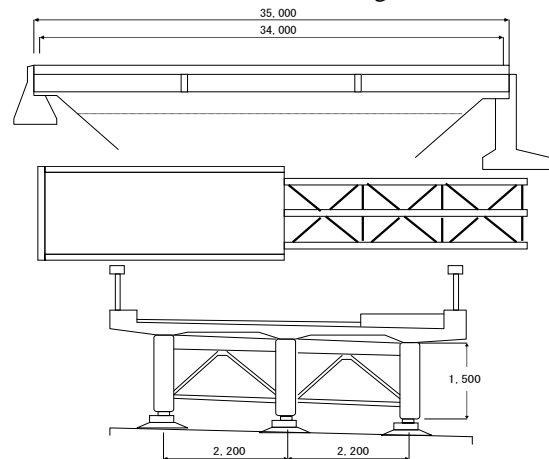
Fig.1 Study Bridge

In the present study, we carried out evaluation of corrosion characteristic for steel girder type bridges using weathering steel bridge under the real severe accelerated corrosion environment. Corrosion bridge is shown in **Fig.1** and **Photo.1**. This bridge type is simple composite steel girder bridge with 3 main girders. Length of bridge is 35.0m and width is 6.4m. Steel products are SMA50A, SMA50B, SMA41A and SS41.

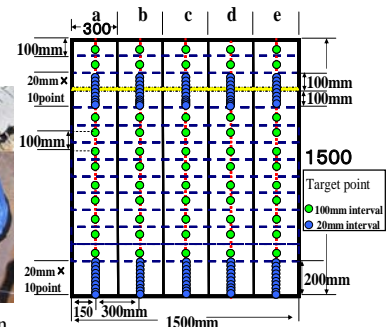
Fig.4 Measurement Procedure of the Web

The thickness measurement carried out the corrosion member of plate. The measurement of the web uses the ultrasonic thickness gage (5MHz type). The measurement procedure of the web is shown in **Fig.4**. The measurement situation is shown in **Phot.2**.
